**DEPARTMENT OF TRANSPORTATION**

Contract #: 04-0120F4Cty: SF/ALA Rte: 80 PM: 13.2/13.9File #: 99.28**WELDING INSPECTION REPORT****Resident Engineer:**Siegenthaler, Peter**Address:** 333 Burma Road**City:** Oakland, CA 94607**Report No:** WIR-018124**Date Inspected:** 14-Nov-2010**Project Name:** SAS Superstructure**OSM Arrival Time:** 700**Prime Contractor:** American Bridge/Fluor Enterprises, a JV**OSM Departure Time:** 1900**Contractor:** Zhenhua Port Machinery Company, Ltd (ZPMC) Chanxing Island**Location:** Shanghai, China**CWI Name:** Mr. Xu Tao**CWI Present:** Yes No**Inspected CWI report:** Yes No N/A**Rod Oven in Use:** Yes No N/A**Electrode to specification:** Yes No N/A**Weld Procedures Followed:** Yes No N/A**Qualified Welders:** Yes No N/A**Verified Joint Fit-up:** Yes No N/A**Approved Drawings:** Yes No N/A**Approved WPS:** Yes No N/A**Delayed / Cancelled:** Yes No N/A**Bridge No:** 34-0006**Component:** OBG Bike Path**Summary of Items Observed:**

# WELDING INSPECTION REPORT

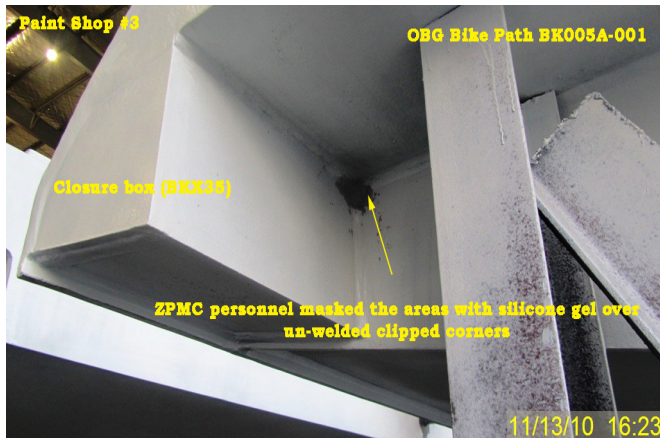
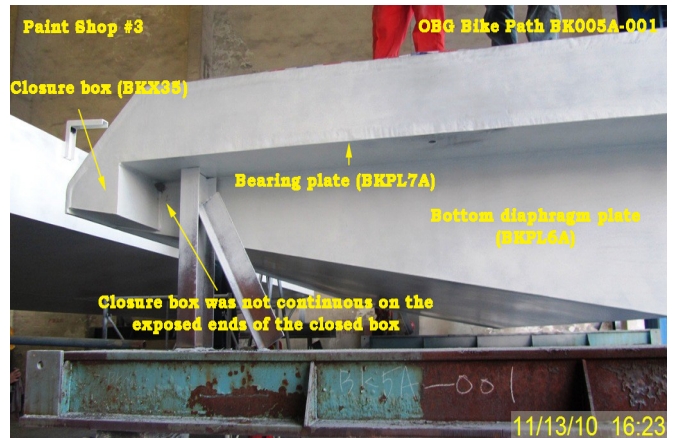
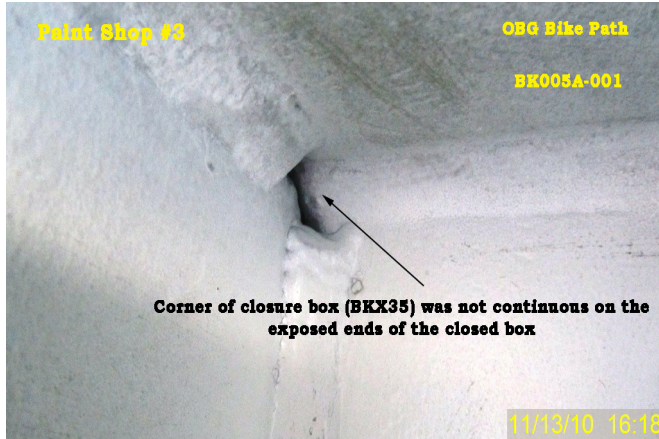
Description of Incident: During the Caltrans Quality Assurance in-process observations of the fabrication of Bike Path, this Quality Assurance Inspector (QA) observed that the welding at the corner of closure box (BKX35) was not continuous on the exposed ends of the closed box on each side. Shop drawing piece mark number (BKX35C) shows the location of the clipped corners. ZPMC personnel masked the areas with silicone gel over un-welded clipped corners. The closure box (BKX35) is welded to the bottom diaphragm plate (BKPL6A) and bearing plate (BKPL7A). The Bike Path Panel is identified as BK005A-001. The ZPMC QC is identified as Mr. Xu Tao. The material is identified as a Non Seismic Performance Critical Member (Non SPCM). This OBG Bike Path has been loaded onto the ship in preparation for shipment to the USA. See the attached pictures.
